# Packet & Timing Analysis

This application note describes an example of how the packet capture and analysis capabilities were used to diagnose network equipment performance issues.

## Network Performance Issues

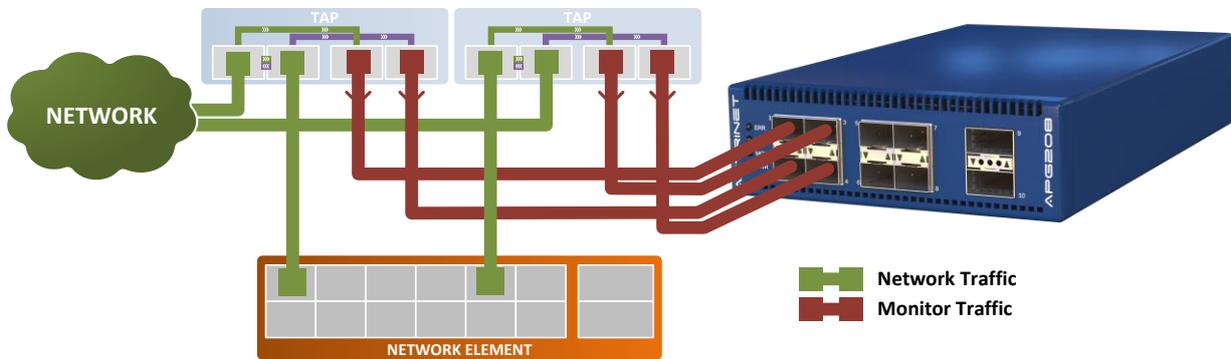
Using breakout taps either side of the failing network element enabled full access to the data before and after the device in both directions. A breakout tap connects Ports A & B, whilst replicating received traffic on Port A to Port C, and Port B to Port D.

Data flowing A→B through the faulty element was monitored on tap ports C, and data flowing B→A was monitored on tap ports D.
